**STATENS GEOTEKNISKA INSTITUT**  
**SWEDISH GEOTECHNICAL INSTITUTE**

**RAPPORT**  
**REPORT**      **No 18**

**The Landslide at Tuve**  
**November 30 1977**

**ROLF LARSSON**  
**MATS JANSSON**

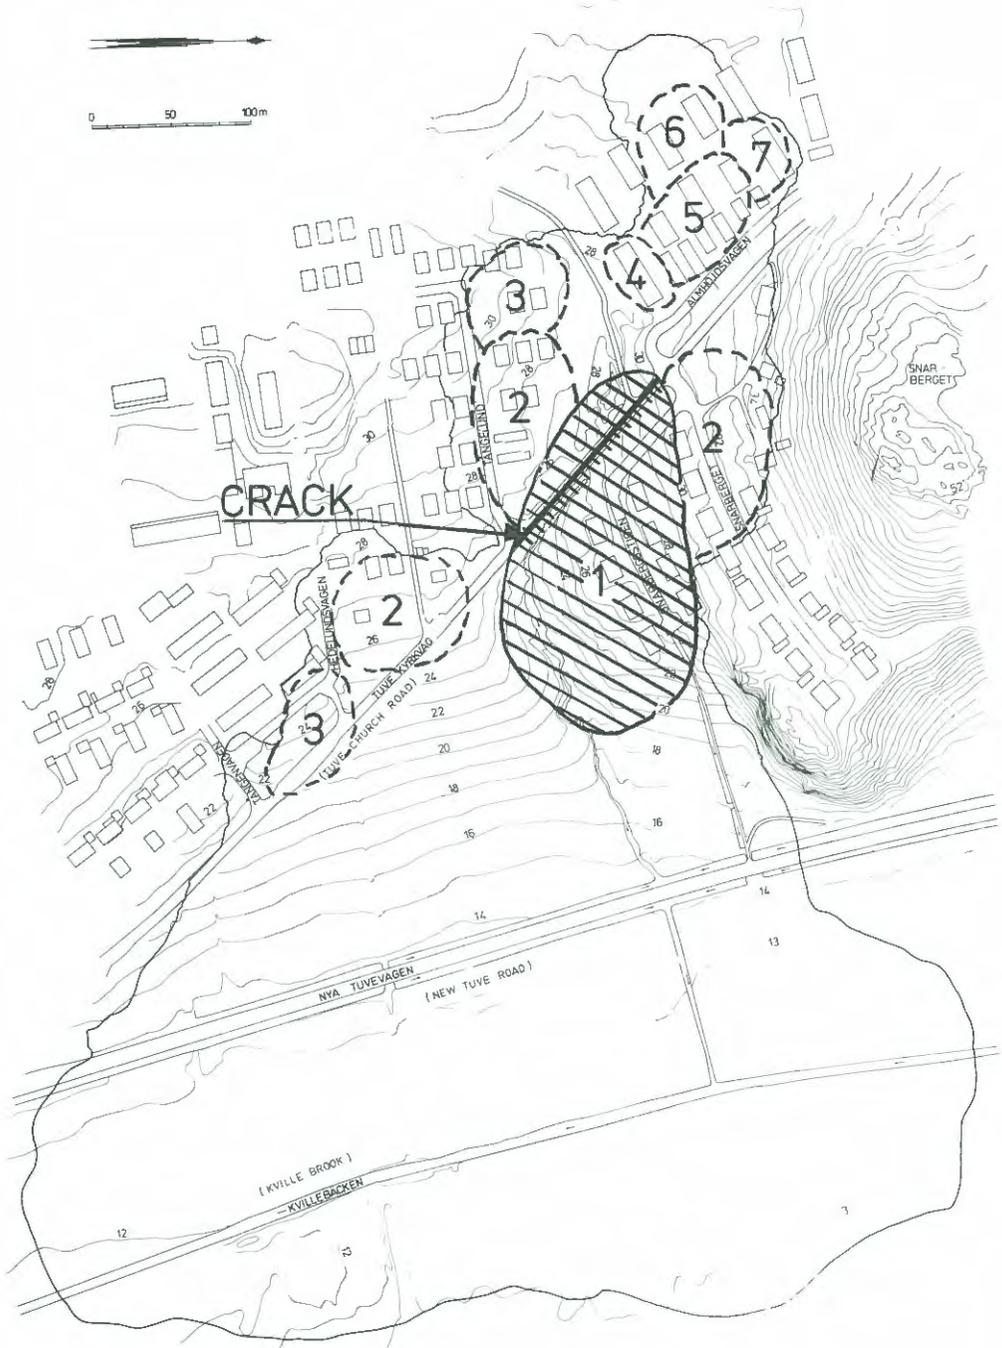
The first obvious sign of large soil movements was the formation of a crack in Tuve Church Road. The crack ran from the bus stop at Snarberget down to the exit from Tångelund, Fig 11. In the following moments parts of Tuve Church Road were seen to move down towards New Tuve Road followed by the houses at Snarbergsstigen and Snarberget in succession. At about the same time as the houses at Snarberget were seen

FIG 11. Sequence in which housing-areas started to move according to eye witnesses.

to be in motion the eastern houses in Tångelund and the houses at Hedlundsvägen started to move. The slide then retrogressed and the houses at Tångenvägen and the rest of the houses in Tångelund followed. The slide area then reached Almhöjdsvägen and the rows of houses started to slide away one after another. The sequence in which the houses were observed to set in motion is shown in Fig 11 and the horizontal displacements of the individual houses are shown in Fig 12.

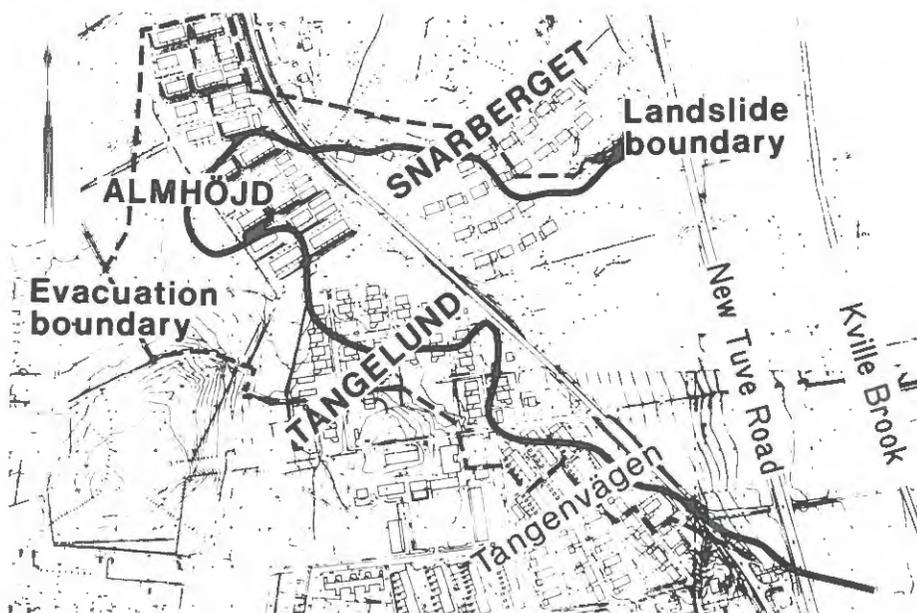
The most important task for the geotechnical engineers directly after the slide was to define what area was in danger of further slides or movements. Apart from the 65 houses which were carried away in the slide another 130 houses were considered in danger just after the slide. For a short while yet another 100 houses were considered unsafe and an evacuation of these was started. However, after preliminary geotechnical investigations this evacuation was stopped. The investigations required to establish the limits of the danger zone were carried out during the first week after the slide. A boundary for the danger area was drawn on December 9, Fig 13. This permitted the inhabitants to move back into 46 houses while 84 houses were considered unsafe. This boundary was kept in the first stage of the reconstruction work.

FIG 13. Boundary of the evacuation zone.

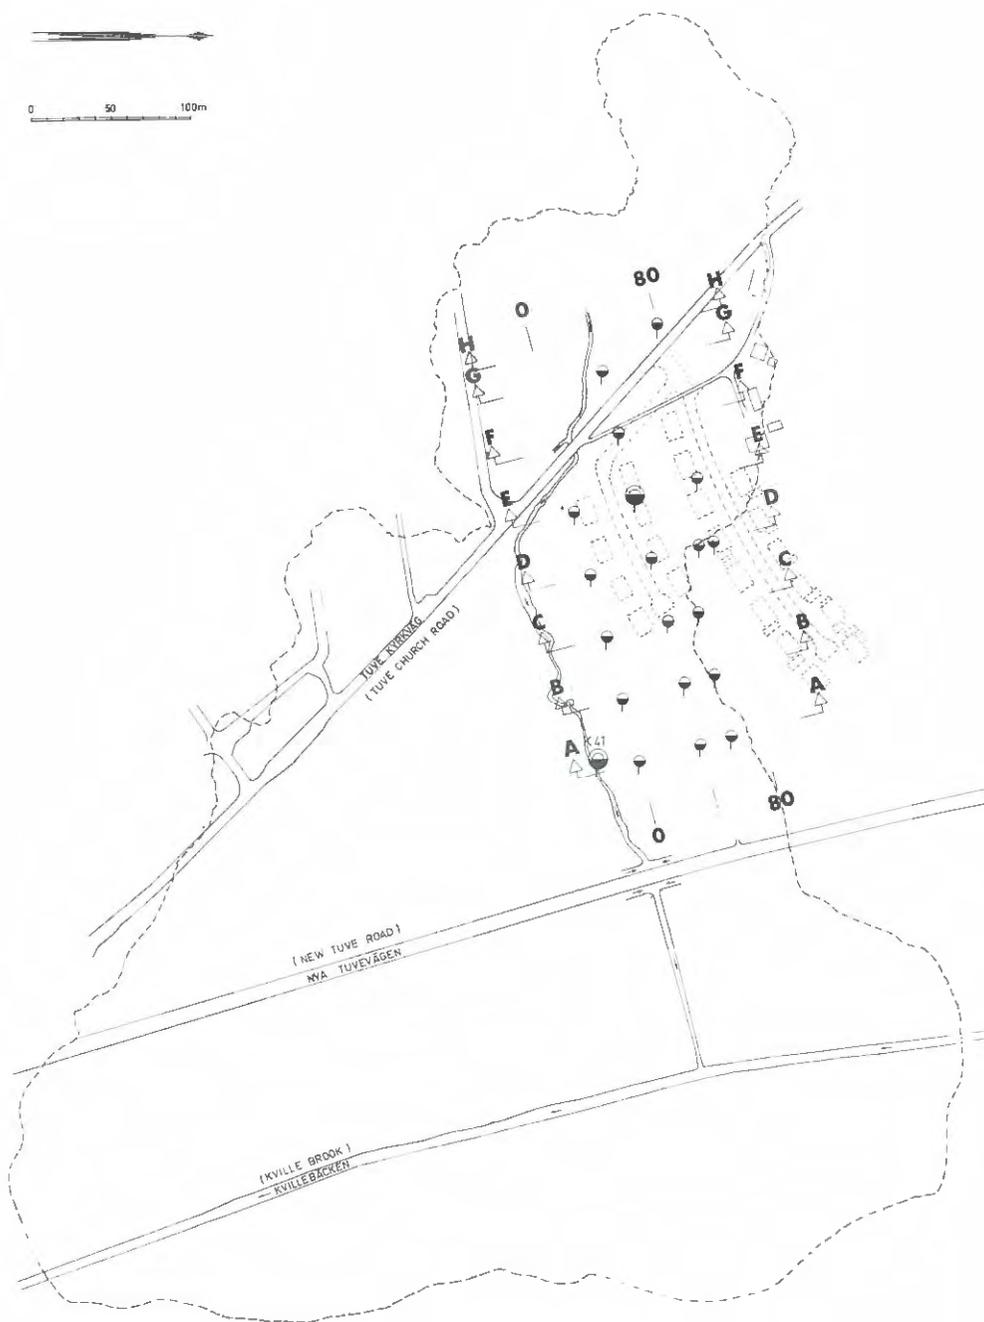
The penetration tests generally show that the tip resistance, which normally increases with depth, only increased during the first ten metres of penetration, then became constant for some metres and finally decreased towards the bottom. In many cases there was hardly any tip resistance at all for the last three metres before the tip reached the sand layer on top of the bedrock. The penetration results indicate that there was a layer of very loose silty clay/clayey silt or clay with loose silt layers between the clay and the sand.

FIG 15. Earlier investigations of the area between Snarberget and the small brook.

nately no vane tests were made to measure the undrained shear strength prior to the slide.

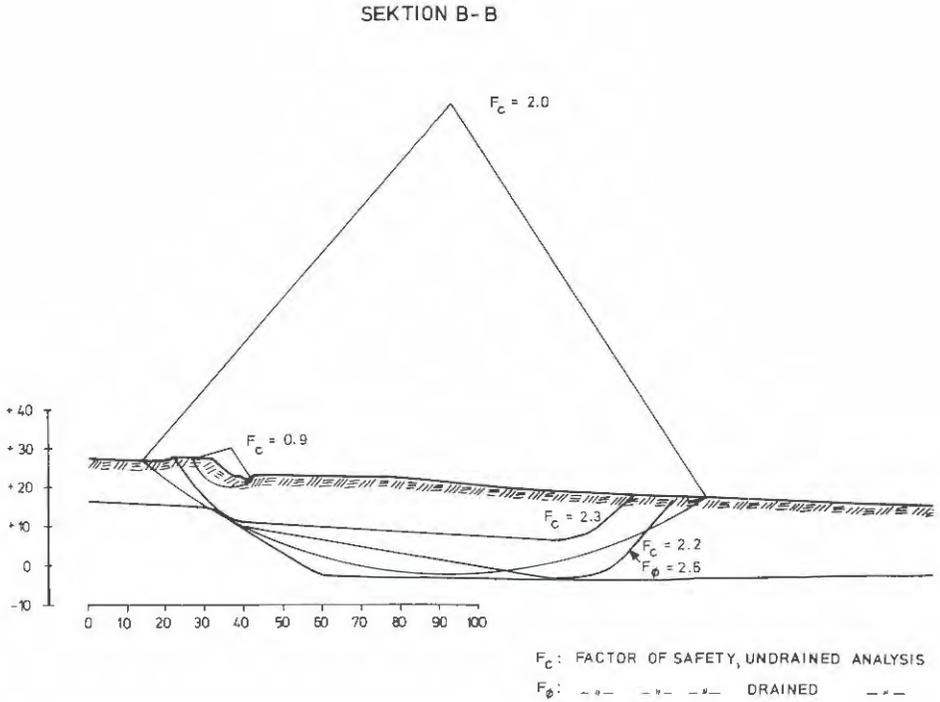
Analyses where the permeable layers in the bottom were assumed to be drained using the empirical effective strength parameters  $c' = 0$  and  $\phi' = 30^\circ$  were carried out. The water pressure in the friction soil below the clay was assumed to be equal to a ground-water level in the ground surface in the areas above Tuve Church Road. Artesian conditions with a head above ground level of 4 m were assumed at New Tuve Road and adjacent to the gully. These calculations gave a considerably higher factor of safety than those using undrained shear strength. Even if the water pressure level in the bottom layers was to be raised by 5 m within the entire area the factors of safety would still be in the range 1.8-2.2, Fig 34.

FIG 34. Results from stability calculations through section B-B (see Fig 19) assuming a continuous increase of undrained shear strength with depth. Increase of shear strength under the embankment due to consolidation has been disregarded.

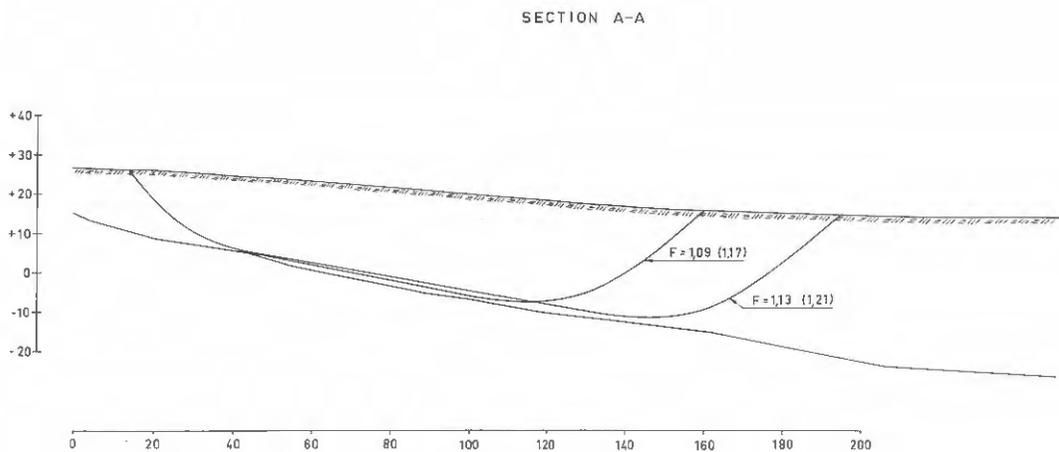
Additional calculations were made using the undrained shear strength that empirically should have been measured by the field vane test in the particular conditions. The conventional assumptions with a water filled crack and no strength increase in the dry crust were made. These calculations gave factors of safety between 1.1 and 1.3 for the slip surfaces which gave factors of safety between 1.0 and 1.1 when softening, pore pressures and anisotropy had been taken into account.

FIG 35. Results from stability calculations assuming empirical shear strengths and using the lowest alternative of drained and undrained shear strength in active and direct shear zones. The passive shear strength in the dry crust is assumed to be 12 kPa. Safety factors in brackets refer to conventional analyses using empirical undrained shear strengths as obtained in field vane tests.

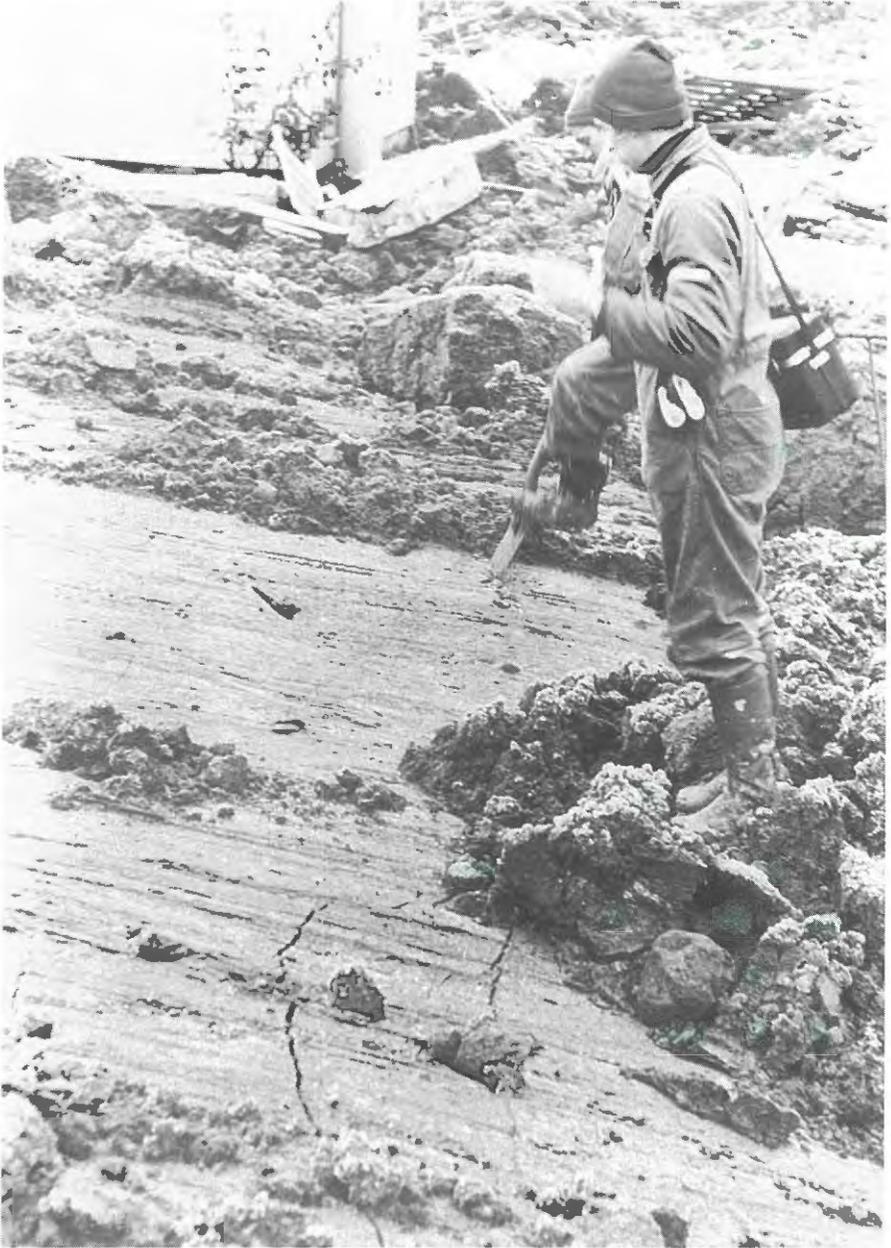
*The ground surface in the passive zone.*

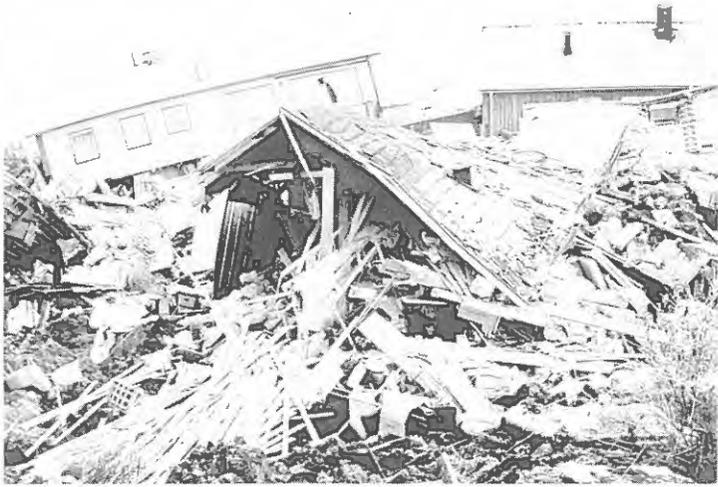
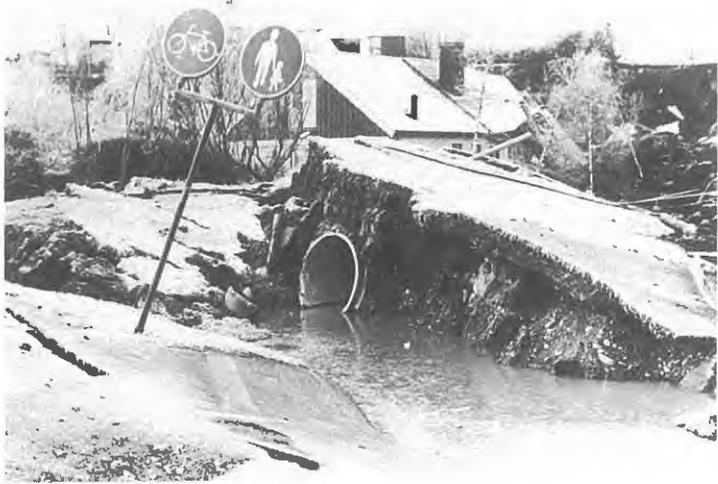
*Demolished houses and broken up ground in the slide area.*

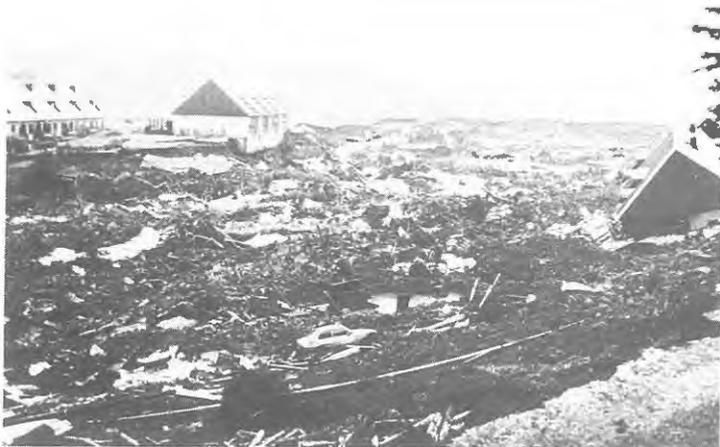
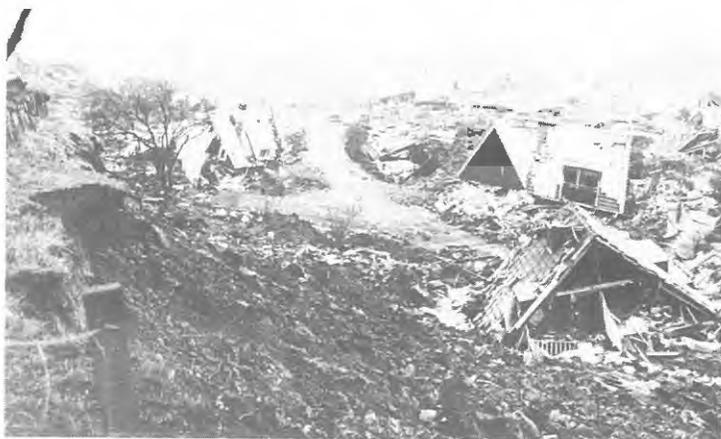
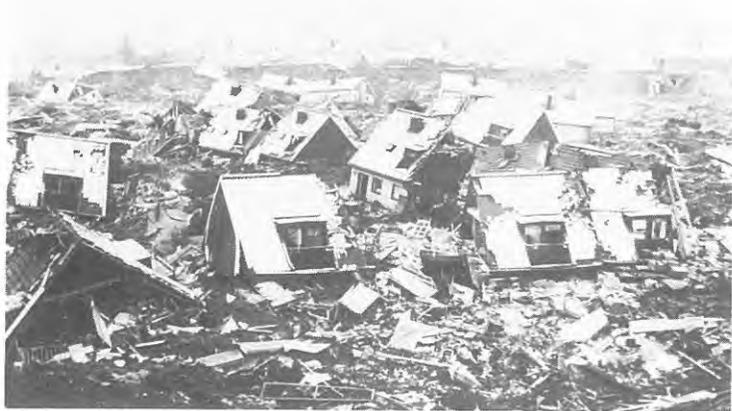
*Views of the slide area.*
