**STATENS GEOTEKNISKA INSTITUT**  
**SWEDISH GEOTECHNICAL INSTITUTE**

**RAPPORT**  
**REPORT**      **No 18**

**The Landslide at Tuve**  
**November 30 1977**

**ROLF LARSSON**  
**MATS JANSSON**

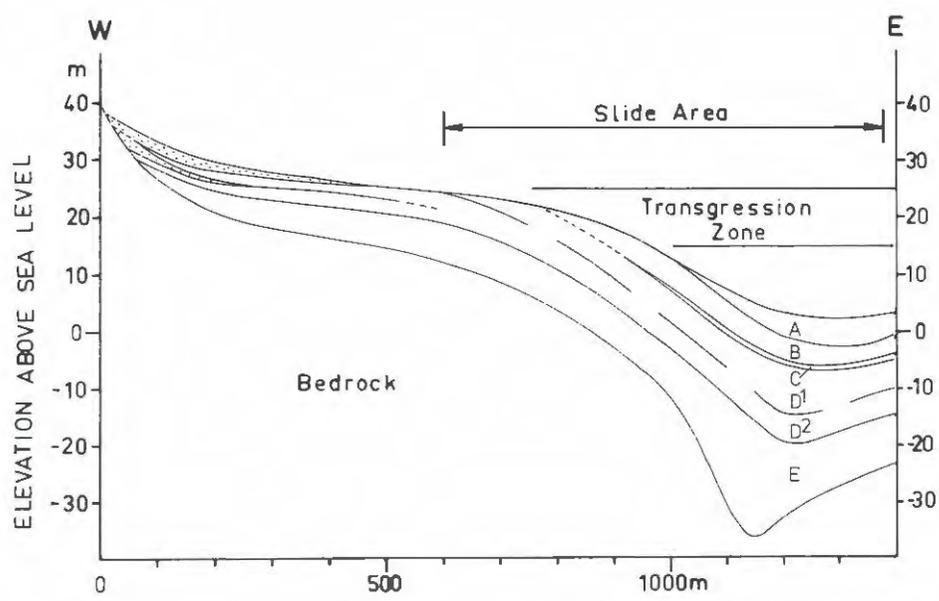
A varved glacial clay (Zone E), characterized by several layers of sand and silt rests directly on the Precambrian bedrock. This zone was deposited close to the retreating ice front. After the landslide it was found that the silt/sand layers were highly permeable (SGI report No 11c). Very high pore

FIG 10a. Generalized soil profile through the slide area at Tuve. Geological zones. (Cato et al, 1981.)

pressures were measured in the upper part of this zone after the slide and the slide surfaces seem to have followed the zone.

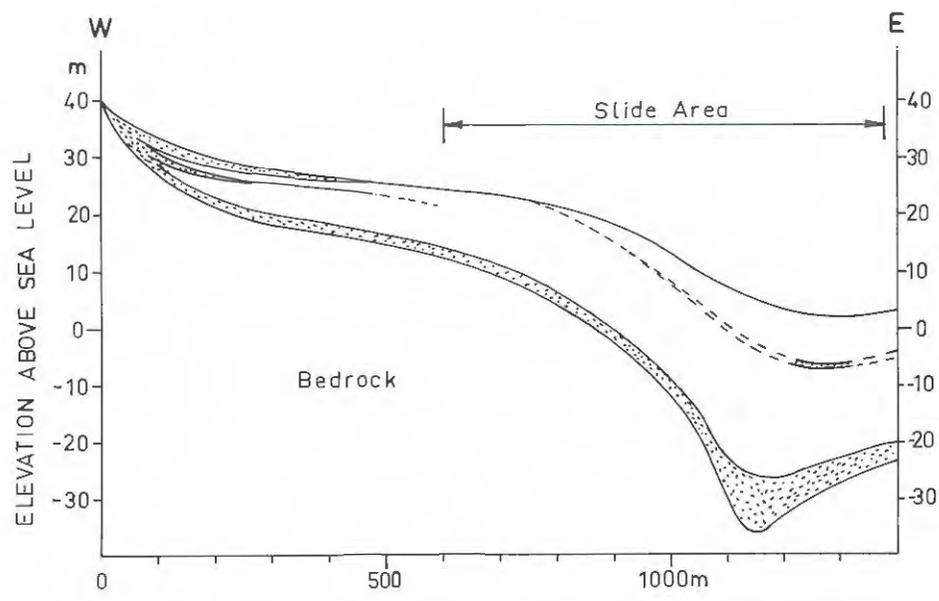
FIG 10b. Generalized soil profile through the slide area at Tuve. Zones where layers of sand and silt occur (dotted).

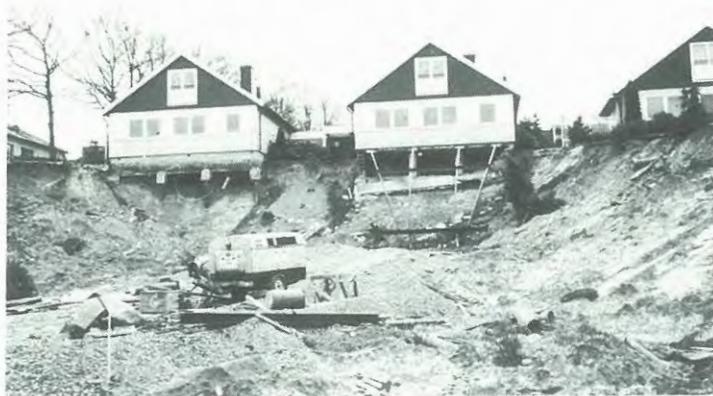
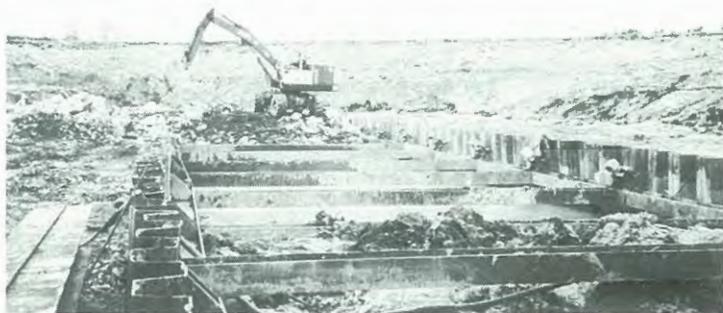
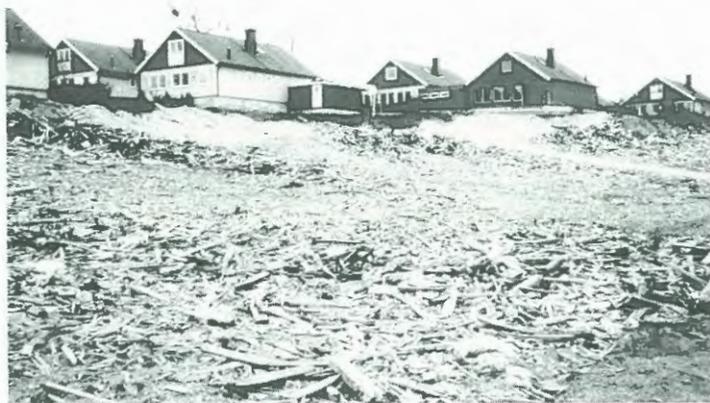
*FIG 14. Reconstruction work in the slide area.*

*Temporary support  
for houses.*

*Placing of rockfill  
between back tied  
sheet walls*

*Lightweight fill to  
improve stability.*

Directly after the slide a number of temporary stabilizing measures were taken. At an early stage fibre-concrete was sprayed at parts of the steep back scarp of the slide area to prevent superficial slides in the clay. This measure proved to be successful. Some houses were supported by beams and struts. Others were secured by temporary lightweight fills. These measures were aimed at preventing further destruction of the houses before they could be restored or in some cases at enabling safe removal of personal property before demolition of the buildings, Fig 14.

South of the Almhöjdarea, which was the largest housing area in the danger zone, two back tied sheet pile walls were put into place before the soil between them was excavated and the rockfill was tipped in, Fig 14.

Back tied sheet pile walls were also used in some places north of Tängelund. When making calculations the sheet pile walls were only supposed to ensure stability during the excavation period. For long-term stability calculations only the effect of the rockfill was taken into consideration.

In one small area the clay was too deep for the excavation-refill method and other methods had to be used. Here the clay was stabilized with both circular sheet walls and lime columns.

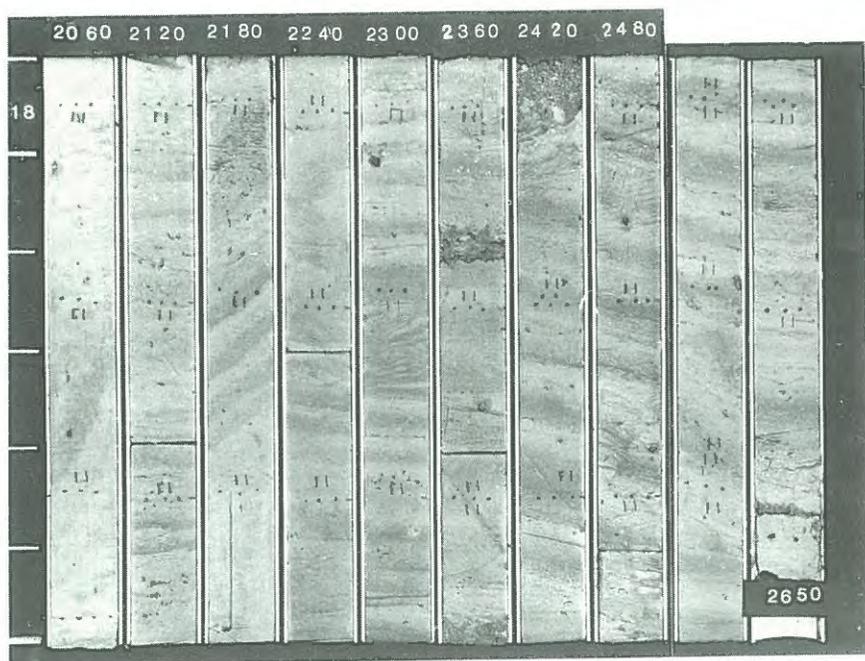
FIG 17a. Stratification in the lower part of core 18.  
 Photograph taken at natural water content.

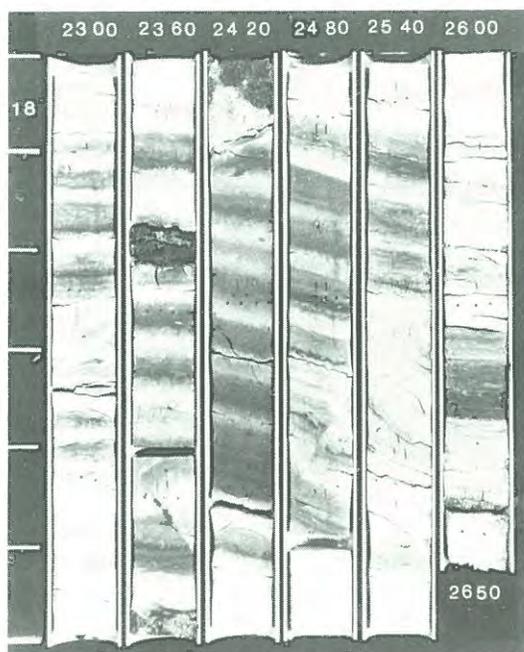
FIG 17b. Stratification in the lower part of core 18.  
 Partly dried.

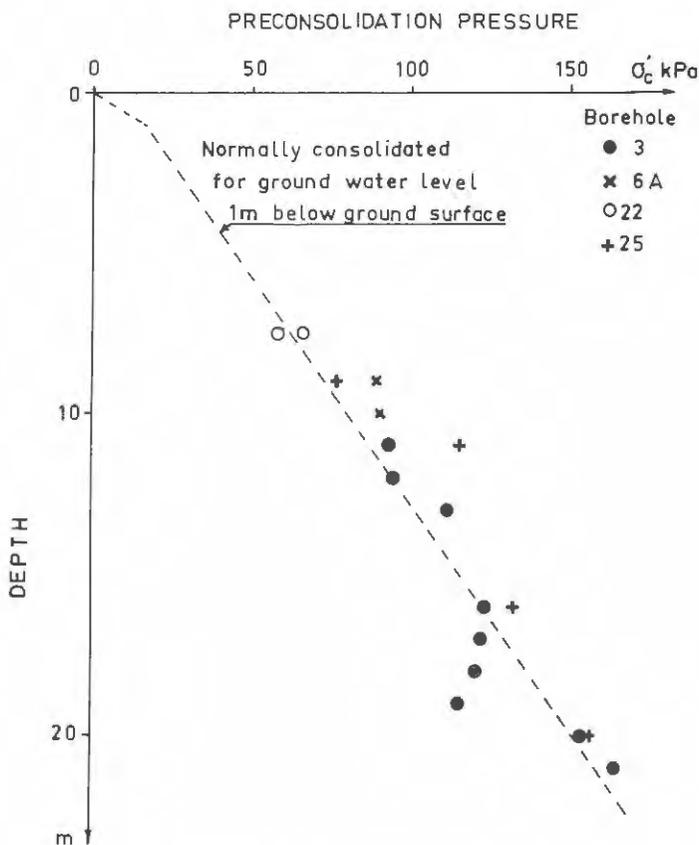
Preconsolidation pressures evaluated from tests on fairly undisturbed samples are shown in Fig 21. The results indicate that the clay below 7 metres was normally consolidated for a groundwater level 1 m below the ground surface. In wet seasons there was artesian water pressures in the bottom layers, which could reduce the effective stresses by 20% at the most. Observations of groundwater fluctuations, however, indicate that there was a large variation of groundwater level in these layers and the temporary high water pressures should not have affected the preconsolidation pressures significantly.

FIG 21. Preconsolidation pressures in the clay at Tuwe.

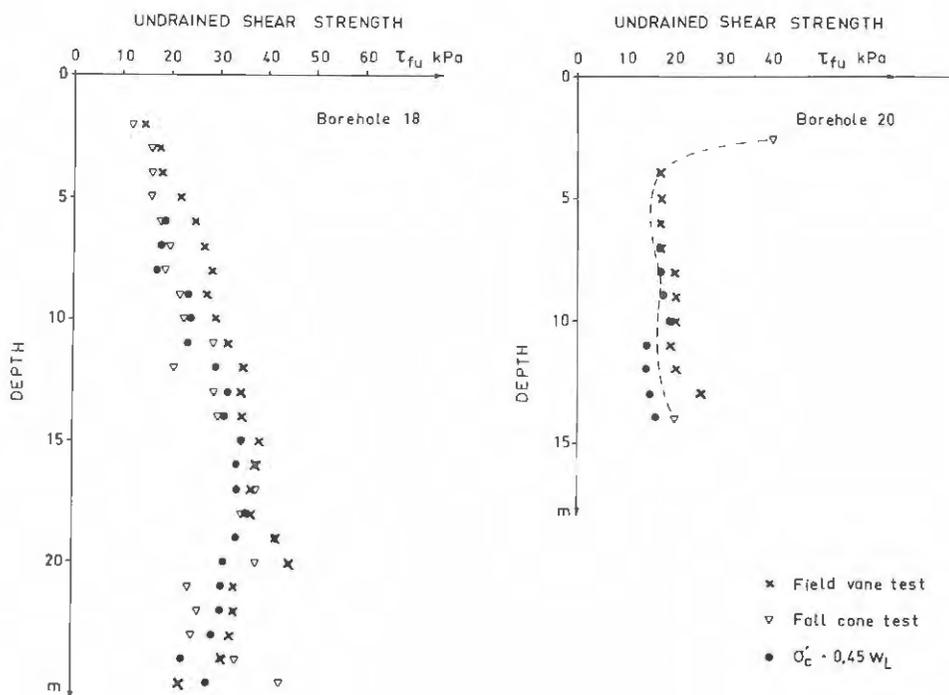
Hansbo's relation has been checked against the undrained shear strength measured by field vane tests and fall cone tests in borehole 18 and 20 which were located outside the slide area, Fig 23. The comparison shows that the empirical relation seems to be largely valid for the clays in Tuve and nothing unusual about the undrained shear strengths from that aspect was found.

FIG 23. Undrained shear strength measured by field vane and fall cone in undisturbed clay from the Tuve area compared to Hansbo's (1957) empirical relation.

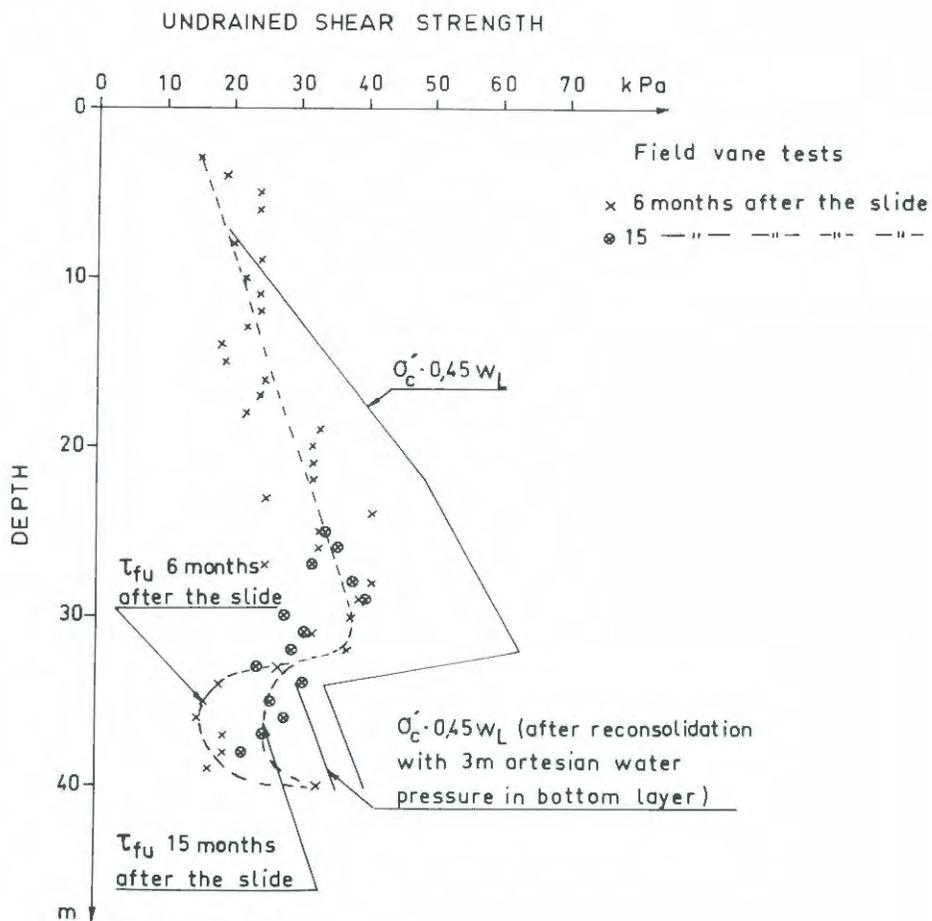
The field vane tests were performed at two different times, 2 to 6 months and 15 months after the slide. Many of the first borings were not carried out all the way to firm bottom and when it was later realized how deep the slide really went supplementary borings were made. In one of the first borings, number 3, the vane tests were continued all the way down but the sampling stopped at a higher level. In the supplementary boring number 26, close by boring number 3, new vane tests and sampling were carried out down to firm bottom. There are thus vane borings in two adjacent boreholes made 6 months and 15 months after the slide, Fig 24.

The undrained shear strength 6 months after the slide in most of the profile was about two thirds of what could have been expected from the empirical relation. In the lower layers it was less than half. In the new tests thirteen months later the undrained shear strength was unchanged in the upper part of the profile but had increased considerably in the lower layers. In this part the undrained shear strength approaches the values calculated with empirical relations and the new measured groundwater level in the sand layers at the bottom of the clay. 6 months after the slide some reconsolidation may be expected already to have occurred in these layers and the results of the vane tests 15 months after the slide certainly indicate reconsolidation. Concerning the other properties of the clay a reconsolidation would mainly have affected the water content, which may be expected to have been higher in these layers before the slide than was measured later.

FIG 24. Field vane tests in boreholes 3 and 26 made 6 and 15 months after the slide compared to empirical relations.

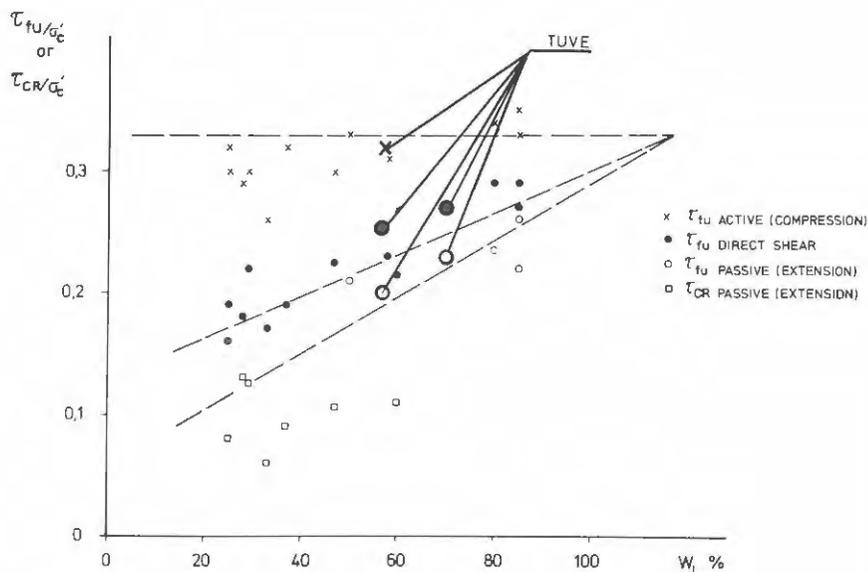
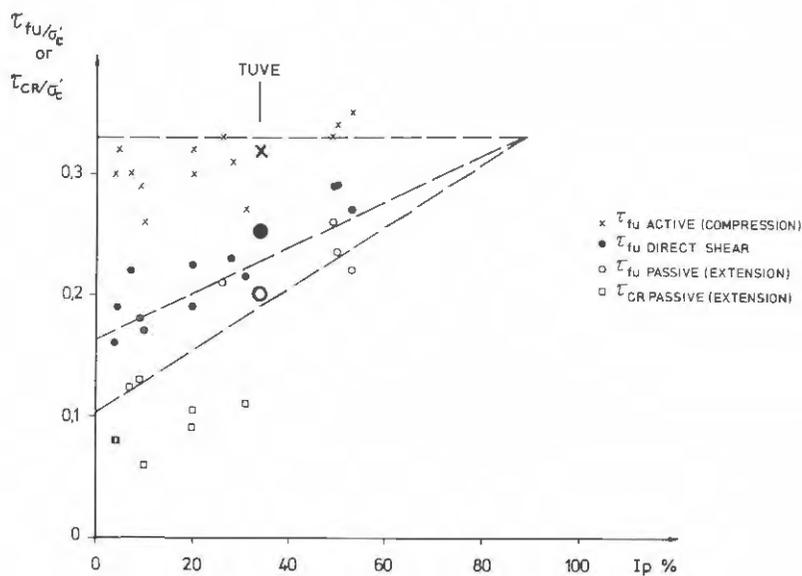
Also for these types of tests there are empirical relations between the undrained shear strength measured in the different types of tests, the preconsolidation pressure and the plasticity of the soil (Larsson, 1977 and 1980). The results from tests on clay from Tuve conform to these empirical relations, Fig 25.

FIG 25. Undrained shear strengths from triaxial and direct simple shear tests on clay from Tuve compared to normal results from other Scandinavian clays. ( $\tau_{CR}$  represents the shear stress mobilized at a deformation corresponding to the failure deformation in the compression test, which is why the peak undrained shear strength in extension is somewhat higher.)

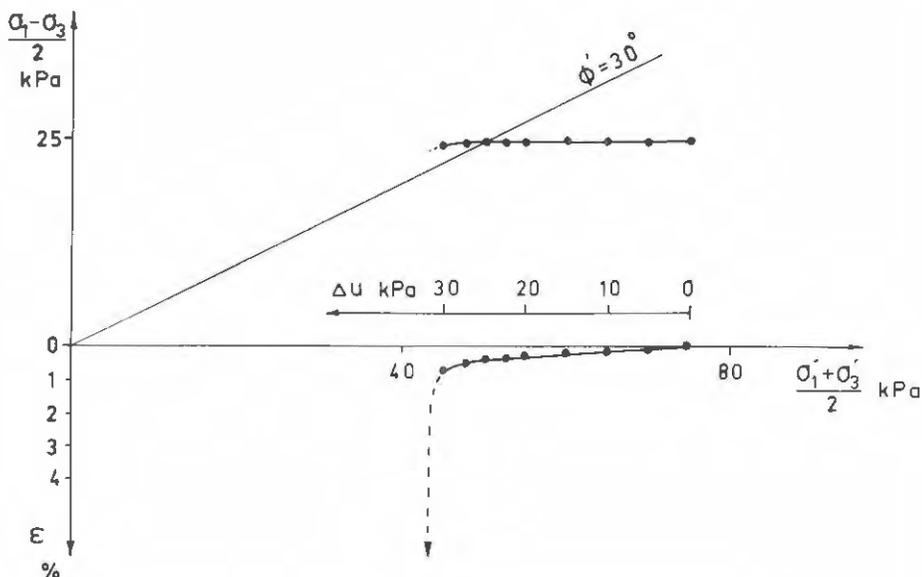
Some special tests to illustrate the effect of rising pore pressures in a soil subjected to shear stresses have been run. In a triaxial test a sample was reconsolidated to *in situ* stresses with a vertical stress of 150 kPa, a horizontal stress of 100 kPa and a pore pressure of 50 kPa. The pore pressure was then raised in small steps and the sample was allowed to absorb water. The result is shown in Fig 26. Very small de-

formations occurred until an effective angle of 30 was mobilized. Then the deformations increased and at a slightly higher effective stress relation the sample failed. Identical results have been obtained in direct simple shear tests in connection with other investigations.

FIG 26. Result from a triaxial test where the sample has first been reconsolidated to in situ stresses and then subjected to a rise in pore pressure.

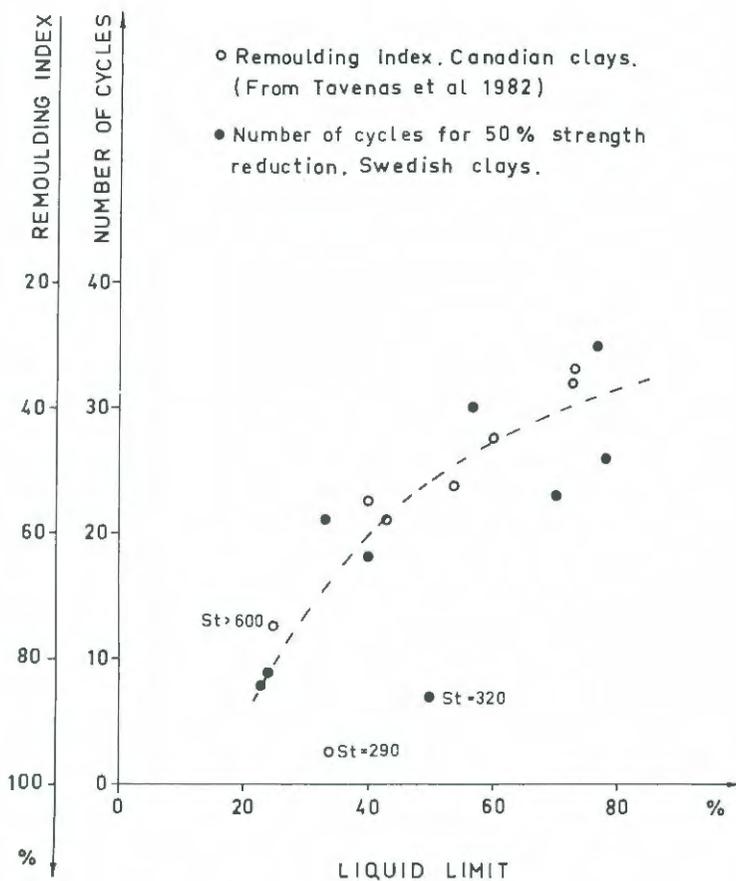
The tests were evaluated in terms of how many cycles were required to reduce the undrained shear strength to half the undrained shear strength measured in standard tests. The results were plotted against liquid limit, sensitivity and liquidity index. Relations could be obtained for all of them and rapidity seems to be dependent on not one but all of them. In soft clays a decreasing plasticity is often accompanied by an increase in liquidity index and sensitivity and this was also generally true for the tested clays, Swedish as well as Canadian. The results from the Swedish and Canadian tests are plotted in Fig 27. The number of cycles for 50% strength reduction or remoulding index  $I_R = (\tau_{fu} - \tau) / (\tau_{fu} - \tau_{REMOULDED})$ , where  $I_R$  is evaluated after an energy input of 40 times the energy required to achieve initial failure, are plotted against liquid limit. There is a clear trend that clays become more sensitive to a limited disturbance the less plastic they are. There are some examples of medium plastic clays which are relatively easily broken down and they also have a very high sensitivity. Since, on the other hand, the sample with the highest sensitivity >600 followed the general trend there must be other factors than sensitivity playing a role. All the samples which were relatively easily broken down ( $I_R > 70$  or  $n < 15$ ) had a high sensitivity. It thus seems that the materials most sensitive to a limited disturbance are also highly sensitive in the ordinary terminology although there is no direct correlation. Low plastic clays and silts are more likely to be sensitive to a limited disturbance than soils with a higher plasticity.

FIG 27. Results from Canadian (Tavenas et al, 1982) and Swedish tests to determine the sensitivity of different clays for limited deformations.

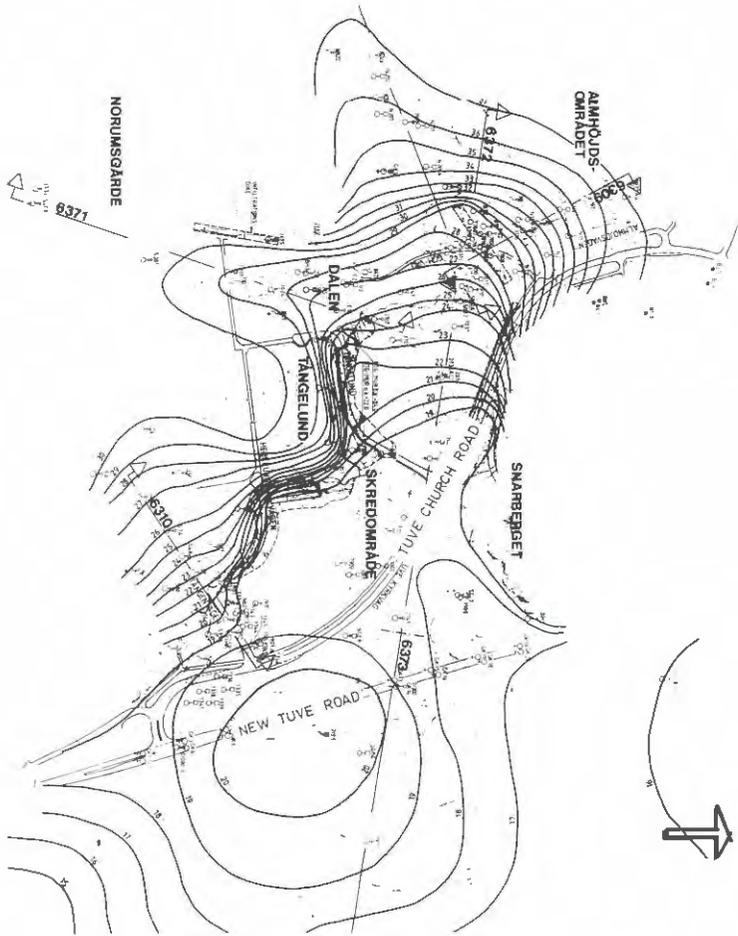
Water pressures measured in the bottom layers in December 1979 are shown in Fig 28.

FIG 28. Groundwater levels in the bottom layers in December 1979. (Blomqvist and Gustavsson, 1981)

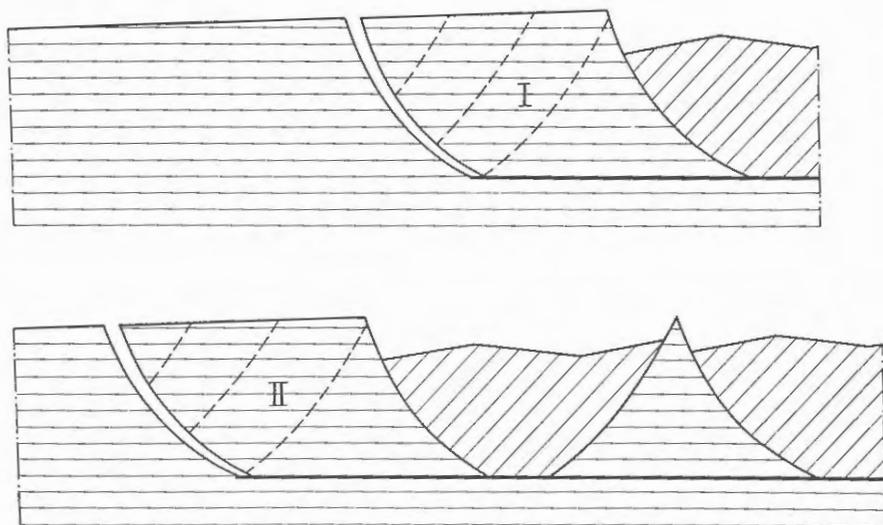
FIG 33. Mechanism of a retrogressive slide along a weak layer according to Odenstad 1951. The blocks slip and break down. A deep cleft is assumed to open behind each slipping block and to remain during the first moments of the slide.

The first and second slides had left high and steep back scarps. The value of  $H \cdot \rho \cdot g$  far exceeded 6 times the undrained shear strength in the weak zone and retrogressive slides mainly in the pattern described by Odenstad 1946, Fig 33, started. The retrogressive slides continued in most places until they reached firm ground. Only in a small part of the western slide area did they end in clay.

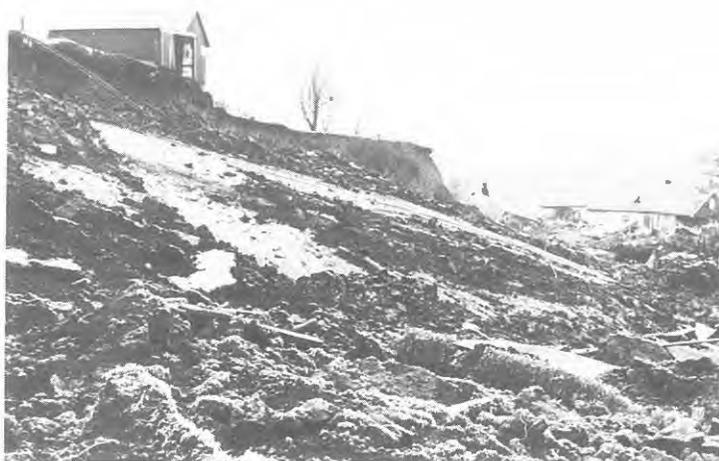
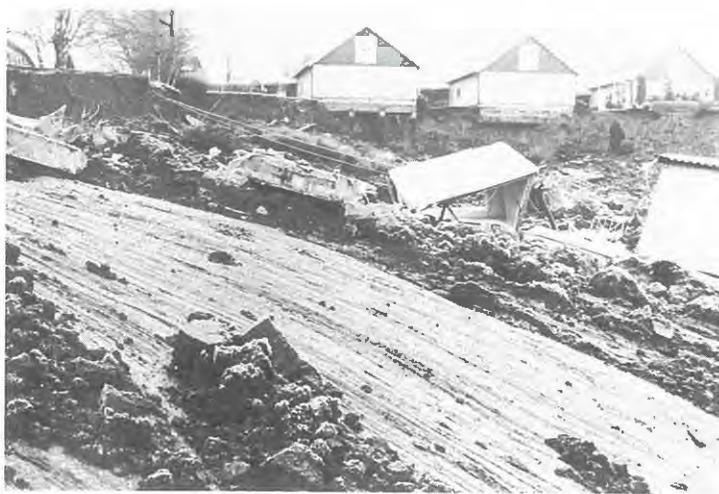
*Slip surfaces close to firm bottom in the upper part of the slide area.*

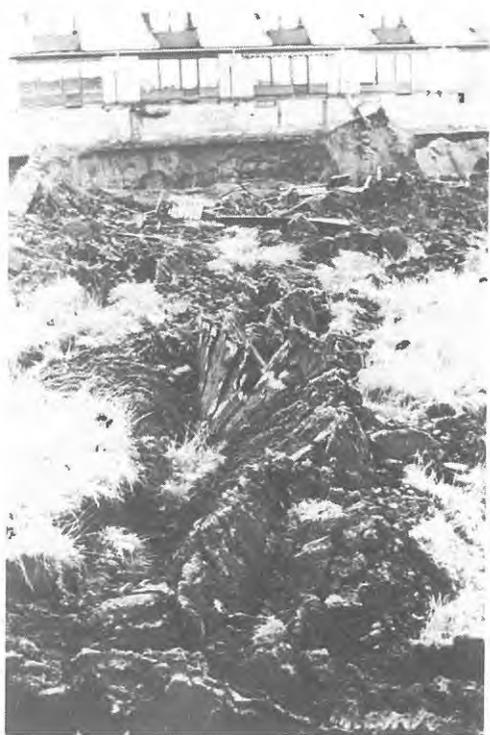
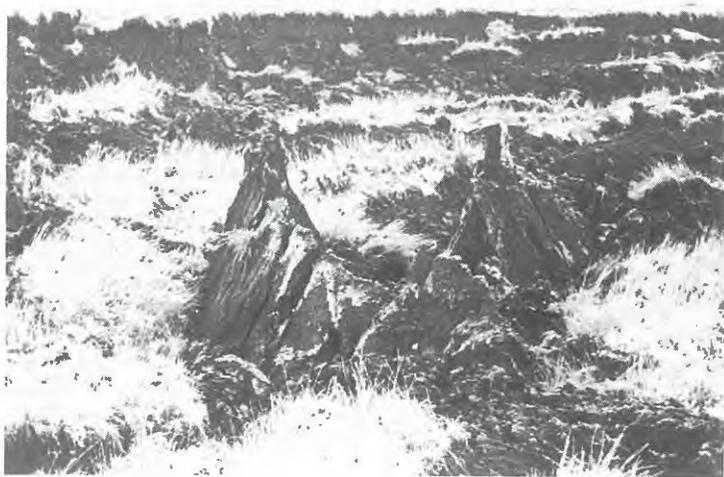
*Steep ridges sticking up in the debris in the active zone (compare chapter 11.2).*

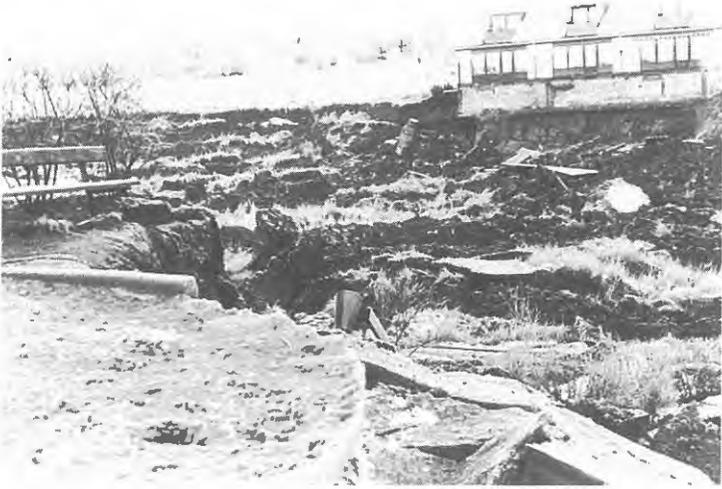
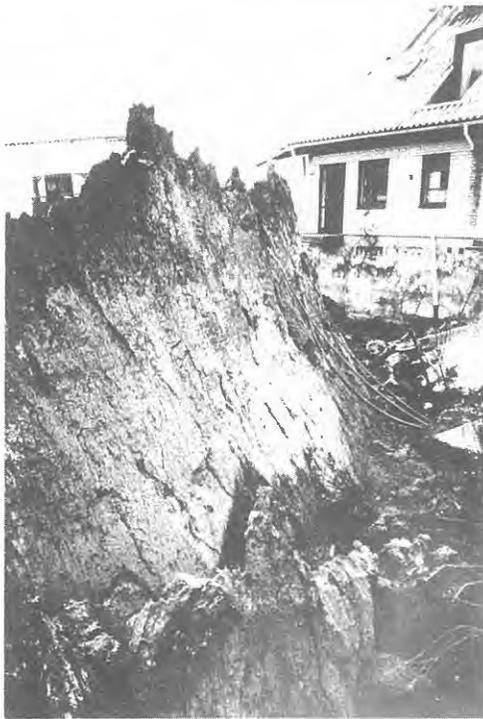
*The ground surface in the passive zone.*
